TECHNICAL NOTE NO. 595

## BENDING TESTS OF CIRCULAR CYLINDERS OF CORRUGATED ALUMINUM-ALLOY SHEET

By Alfred S. Niles, John C. Buckwalter, and Warren D. Reed

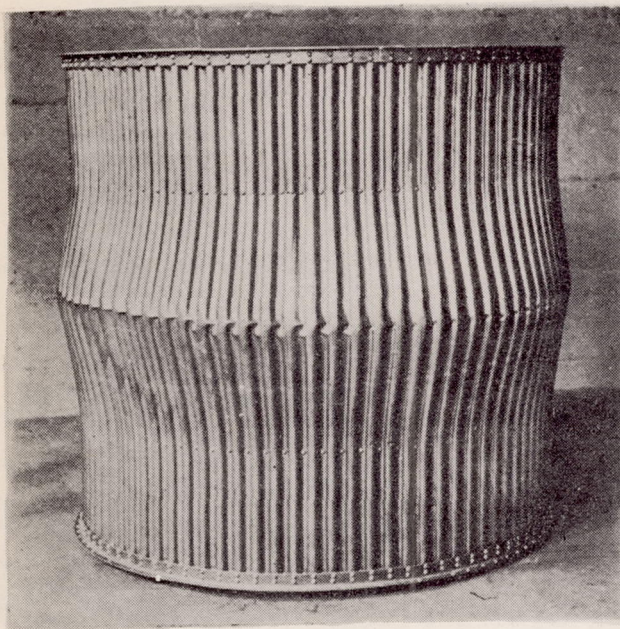
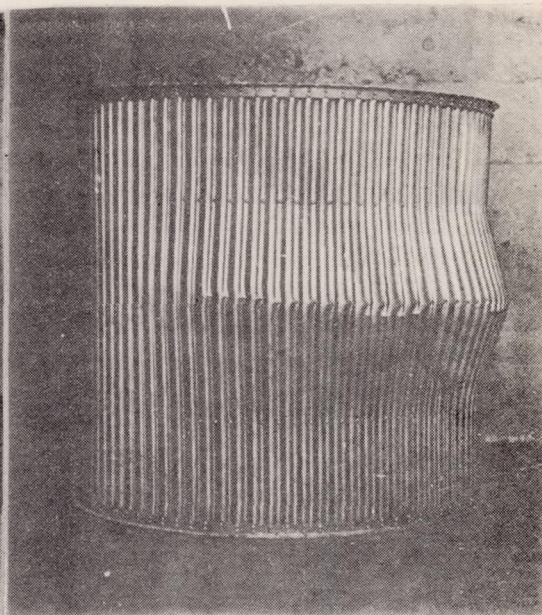
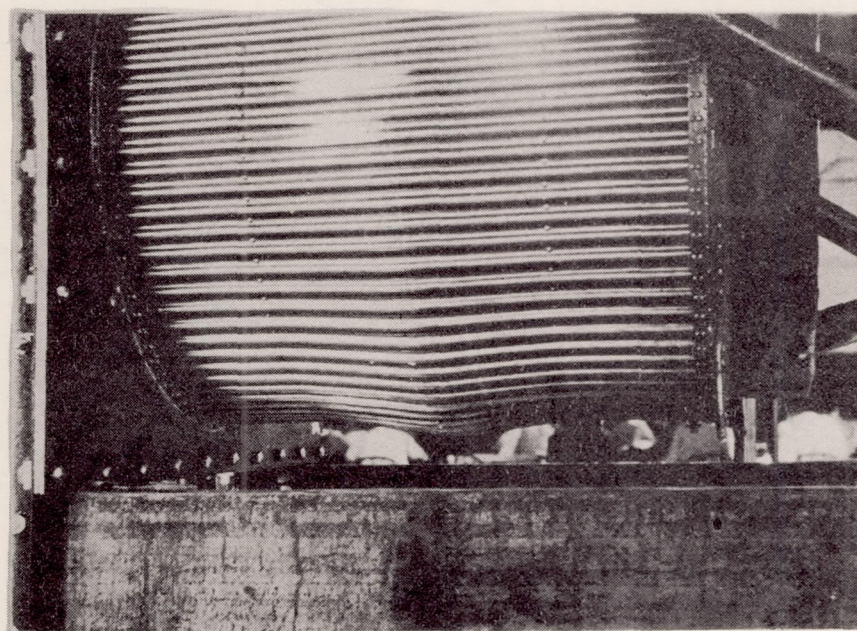
Cylinders 1 and 3, after failure, are shown in figures 1 to 4. It is evident from these pictures that the corrugated sheet in the critical bays behaved in the manner of a column. Final failure occurred in the vicinity of the first bulges to form, the bulges gradually increasing with load until the sheet buckled. In both specimens this buckling at the middle of the panel was accompanied by buckling or cracking of the sheet over the bulkheads at each end of the critical bay. As shown in figure 4, cylinder 3 failed by buckling inward on one side of the vertical axis of the specimen, and outward on the other, while the corrugation at the axis remained practically straight. As noted in the log sheet, before any load was applied,

A corrugated sheet under compression will fail either by bending normal to the plane of the sheet or by local buckling of the corrugations, depending upon which gives the lower strength. In the panel tests mentioned in the preceding paragraph it was found that the strength for local failure was in excess of 34,000 pounds per square inch. As the cylinders failed at computed stresses of 28,400 pounds per square inch and less (table III), it is concluded that failure in the cylinders occurred by bending of the corrugations normal to the skin. This conclusion is also verified by the observed types of failure. (See figs. 1 to 4.)

Figure 1.- Cylinder 1 after failure.

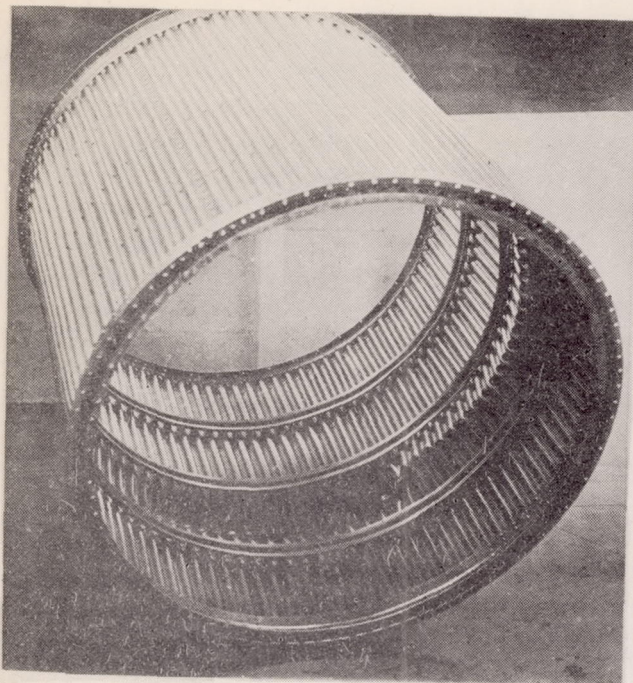
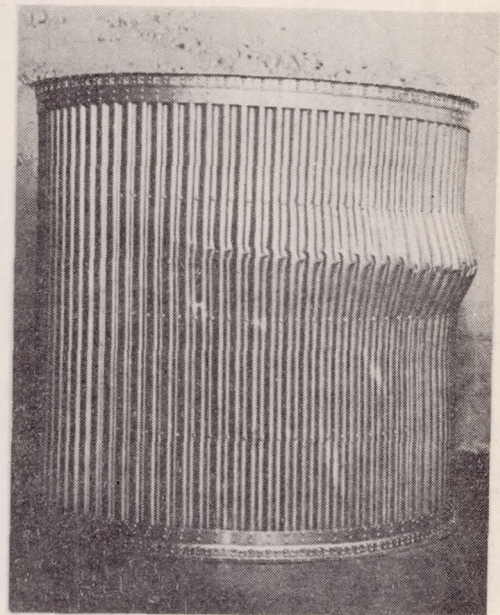
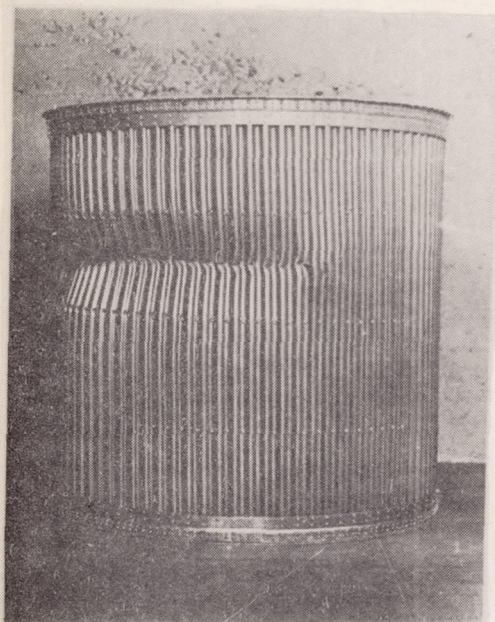
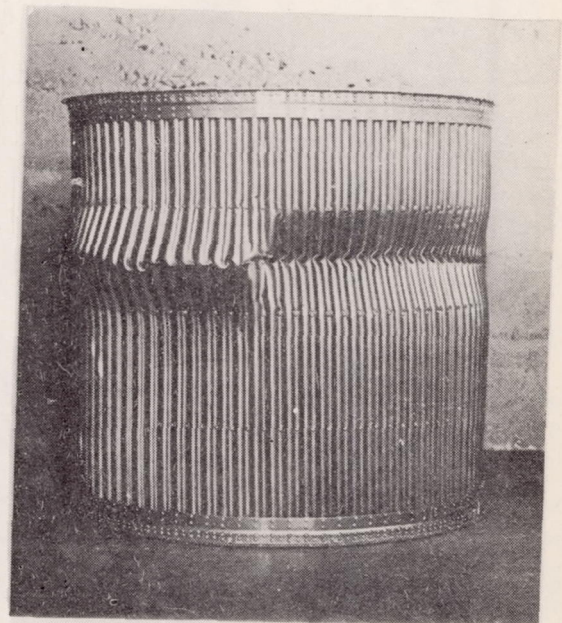
Figure 2.- Cylinder 3 after failure.

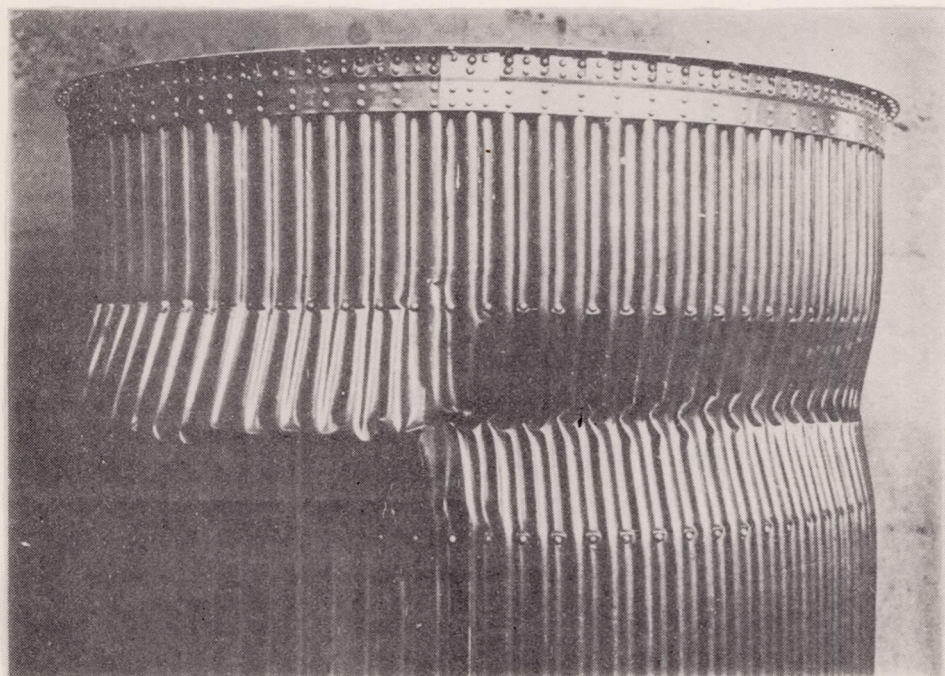
Figure 4.- Failure of cylinder 3.
